# Aviation Investigation Final Report

<b>Location:</b>	San Clemente Island, California	<b>Accident Number:</b>	WPR23FA185
<b>Date &amp; Time:</b>	May 10, 2023, 07:49 Local	<b>Registration:</b>	N56PA
<b>Aircraft:</b>	GATES LEAR JET 36A	<b>Aircraft Damage:</b>	Destroyed
<b>Defining Event:</b>	Fire/smoke (non-impact)	<b>Injuries:</b>	3 Fatal
<b>Flight Conducted Under:</b>	Part 91: General aviation - Other work use

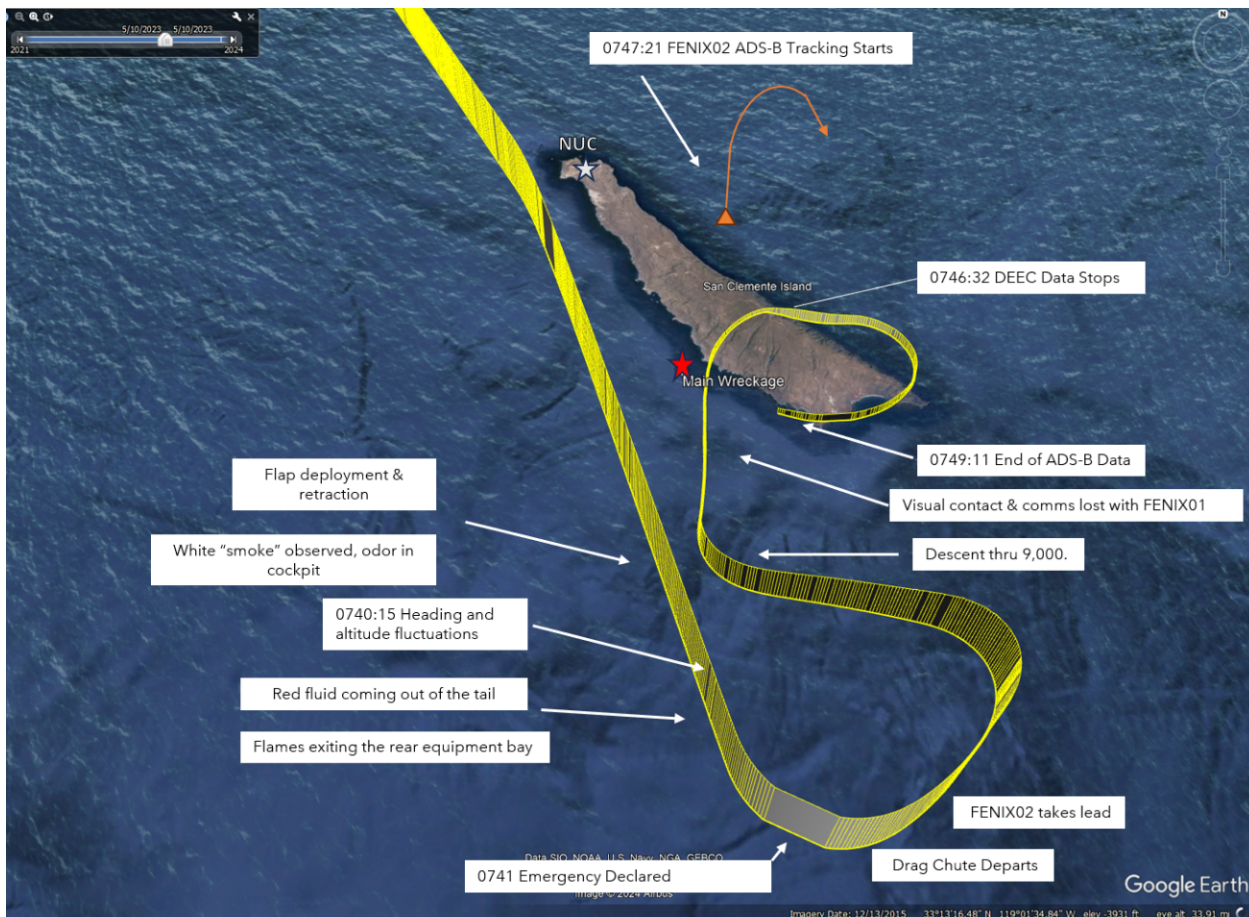
Figure 1 – Flight Path and Sequence of Events

Witness interviews, ADS-B data, Air Traffic Control Transcripts, and flight data from the accident airplane's left engine Digital Electronic Engine Control (DEEC) Incident Recorder were compared and correlated to establish a sequence of events and an approximate timeline (figure 1).

FENIX01 subsequently made a series of right-hand descending turns, during which the DEEC recorded several additional faults between about 0745:43 and when the DEEC data ended about 0746:32 following indications of a loss of power to the DEEC. The last recorded ABS-B data point at 0749:11 showed the airplane at 1,338 ft and heading northwest about ½ mile off the southwest side of San Clemente Island (figure 1) and was about 4 miles southeast of where the airplane’s wreckage was later located.

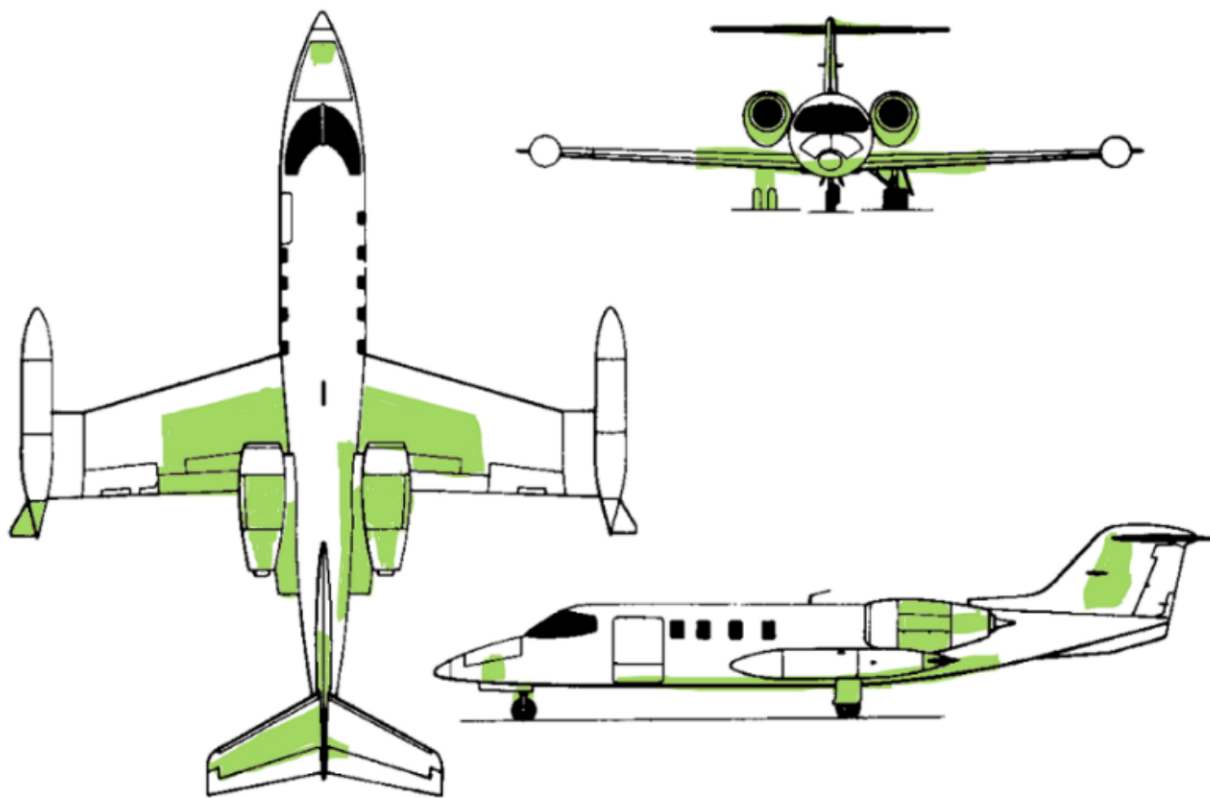
Figure 2 –Portions of the Airplane Recovered (Highlighted in Green)

Investigators examined the wreckage two different times. The wreckage was fragmented and exhibited corrosion consistent with saltwater immersion. It was estimated that about 40% of the airplane was recovered (figure 2). The identifiable wreckage included portions of the nose cone, cockpit instrument panel, cabin floorboard, portions of both wings, both engines and nacelles, some components from the aft equipment bay, and the vertical stabilizer and left horizontal stabilizer.

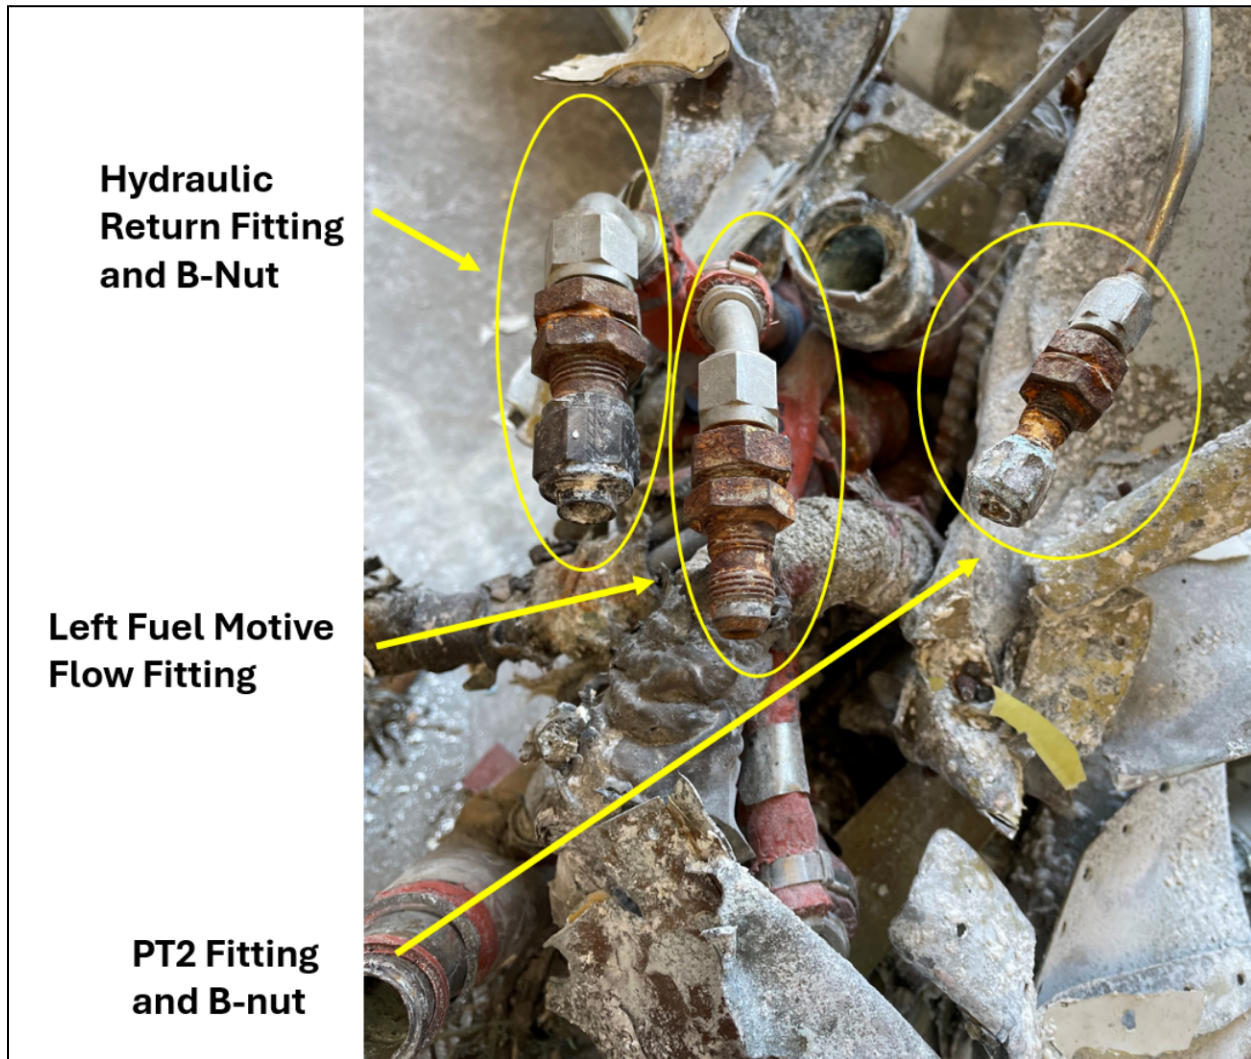
Figure 3 – Left Fuselage Fittings and B-Nuts

Observed fire and heat damage patterns indicate the fire likely started in proximity to the where the pressurized fuel motive flow line connected to the firewall fitting where the missing b-nut was located. A leak from the pressurized motive flow line would have sustained and allowed an uncontrollable fire to develop. The sustained fire likely affected controllability of the airplane and resulted in the pilots' loss of control of the airplane.

The left fuel motive flow line was intact from the fuel pump up to the fuselage fitting, where the line normally passes through the fuselage skin into the aft equipment bay near the aft left engine mount. The fuselage fitting on the aft equipment bay side did not have a b-nut attached nor the line that should connect the fitting to the motive flow valve. The left engine hydraulic pressure line and inlet total pressure (PT2) line, which pass through the fuselage into the aft equipment bay adjacent to the motive fuel line, each had aluminum b-nuts present on the

interior side of their respective fuselage fittings and the interior lines for each was sheared at the fitting (figure 3).

The left fuel motive flow fuselage fitting and the hydraulic fluid return fitting were examined. Both were steel bulkhead type fittings, and both fittings were corroded. No thermal damage was observed on the outboard nuts and attached portions of tubing. On the inboard side, the motive flow fitting was missing the aluminum nut and tubing. Examination of the threads on the inboard side of the motive flow fitting did not exhibit evidence of thread stripping. The hydraulic fluid return fitting still had the aluminum nut attached on the inboard side and the aluminum tubing had sheared at the nut face. According to the operator, there was no record of maintenance being performed on the motive flow fitting and b-nut since the airplane had been assembled.

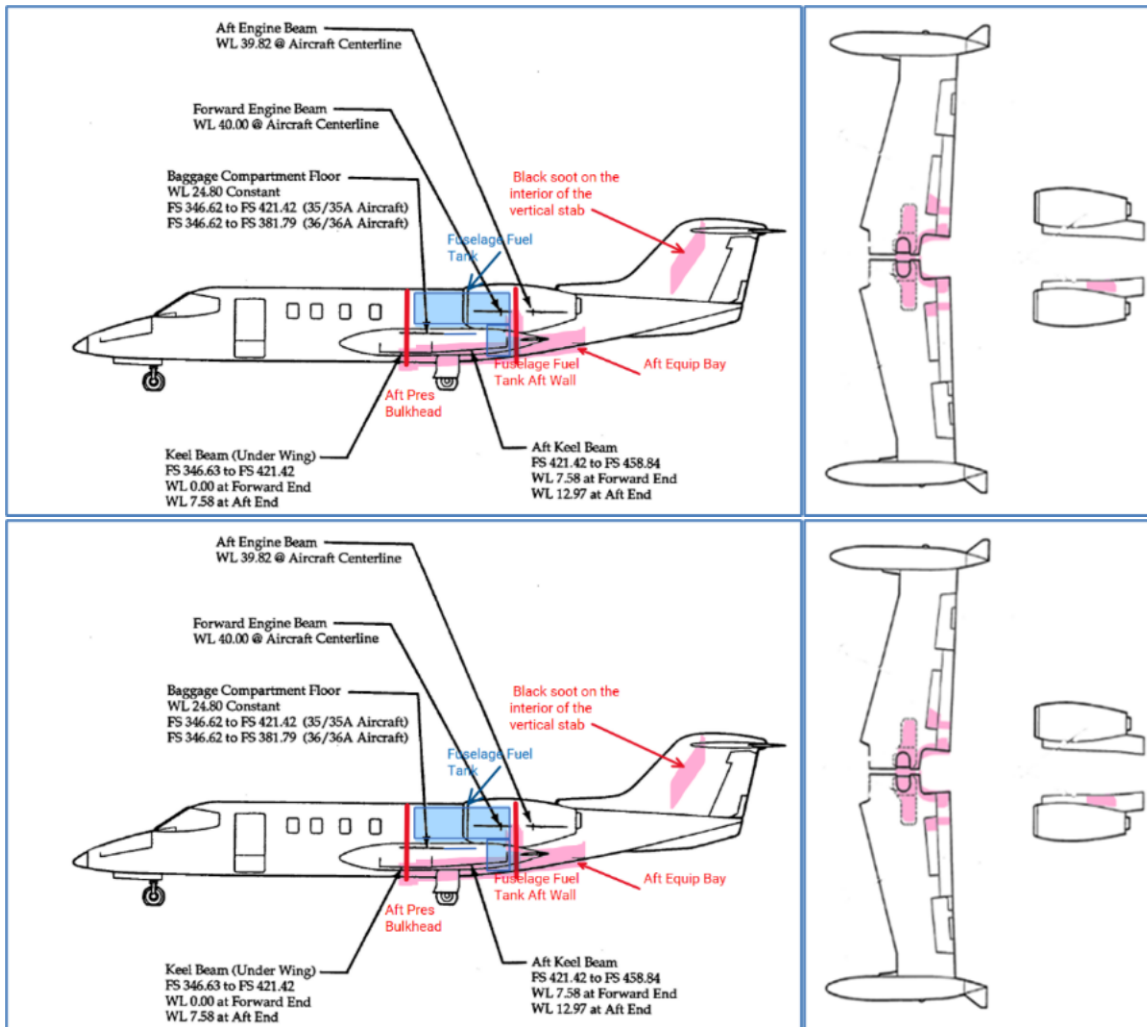
Figure 4. Diagram showing areas of fire/heat damage. (Diagram source: Learjet 20/30 Series Structural Repair Manual)

Fire and heat damage was concentrated in the vicinity of the aft equipment bay (tail cone), aft portion of the fuselage fuel tank, both wheel-well areas and the inboard section of both flaps (figure 4). The right side of the aft equipment bay fuselage structure had heat/fire damage. The left side of the equipment bay and the entire fuselage structure aft of the avionics bay was not recovered.

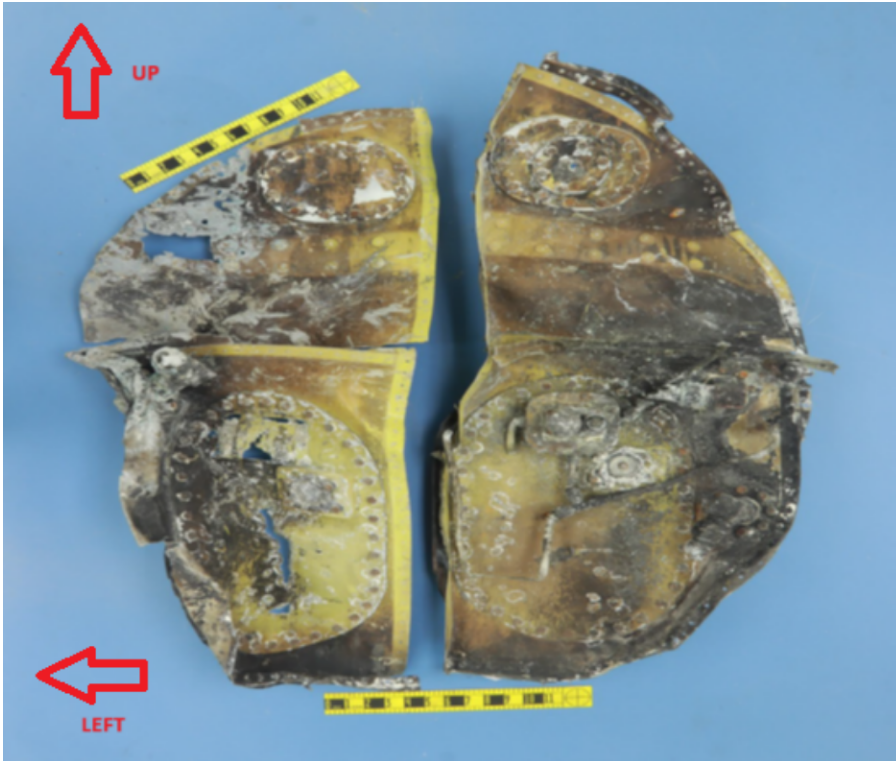
Figure 5 - Fuselage Fuel Tank Aft Bulkhead (Aft Facing Side)

The upper left side of the fuselage fuel tank aft bulkhead exhibited a region of damage that was different than what was observed throughout the rest of the bulkhead (figures 5 and 6). This region of damage was mostly devoid of any remaining charred primer paint and the aluminum substrate was eroded. In some areas within this region, the erosion was all the way through the thickness of the aluminum bulkhead panel. Other areas throughout the entire fuselage fuel tank aft bulkhead that exhibited charred, or missing paint did not exhibit the erosion.

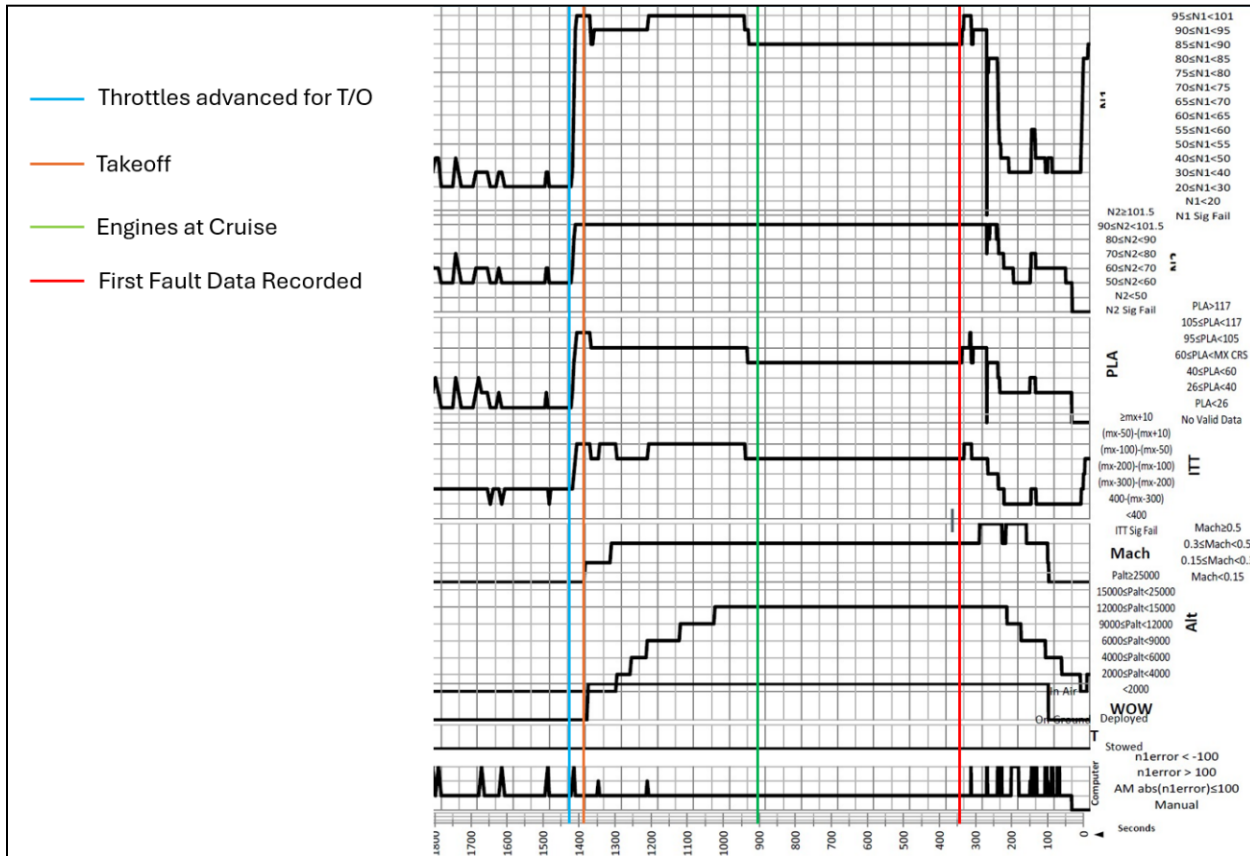
Figure 7 – DEEC Incident Recorder Data

The data recorded 5,120 seconds of data (about 85 minutes). The data includes the cruise, descent, and landing from the flight before the accident and the full data recorded from the accident flight. The accident flight dataset appears to start at about time stamp 1,980 seconds, determined by comparison with the Data File Chronology. At time stamp 50 seconds through the remainder of the dataset, the N2 and PLA parameters indicate N2 Signal Fail and No Valid Data respectively. This coincides with faults indicating a failure of the FCU PLA circuit and the N2 Monopole Circuit being open or shorted consistent with damaged wiring. Per system design the DEEC reverted to manual mode.

Data recovered from the incident recorder associated with the accident flight is displayed in figure 7. For purposes of determining the actual time of the events, there is a PLA increase beginning at about 1430 seconds correlating to the throttles being advanced for takeoff. Six seconds later N1 stabilizes at 101 percent and Mach data begins indicating an increasing trend from zero, consistent with the start of the takeoff roll. The DEEC data was correlated with

ADS-B data for the airplane, which showed the takeoff roll began about 0722:48. The DEEC recorded the first fault about 0741:46 and the incident recorder data subsequently ends about 0746:32.
