# Aviation Investigation Final Report

| <b>Location:</b> | Beaufort, North Carolina | <b>Accident Number:</b> | ERA22LA120 |
| <b>Date &amp; Time:</b> | February 13, 2022, 14:02 Local | <b>Registration:</b> | N79NX |
| <b>Aircraft:</b> | PILATUS AIRCRAFT LTD PC-12/47E | <b>Aircraft Damage:</b> | Destroyed |

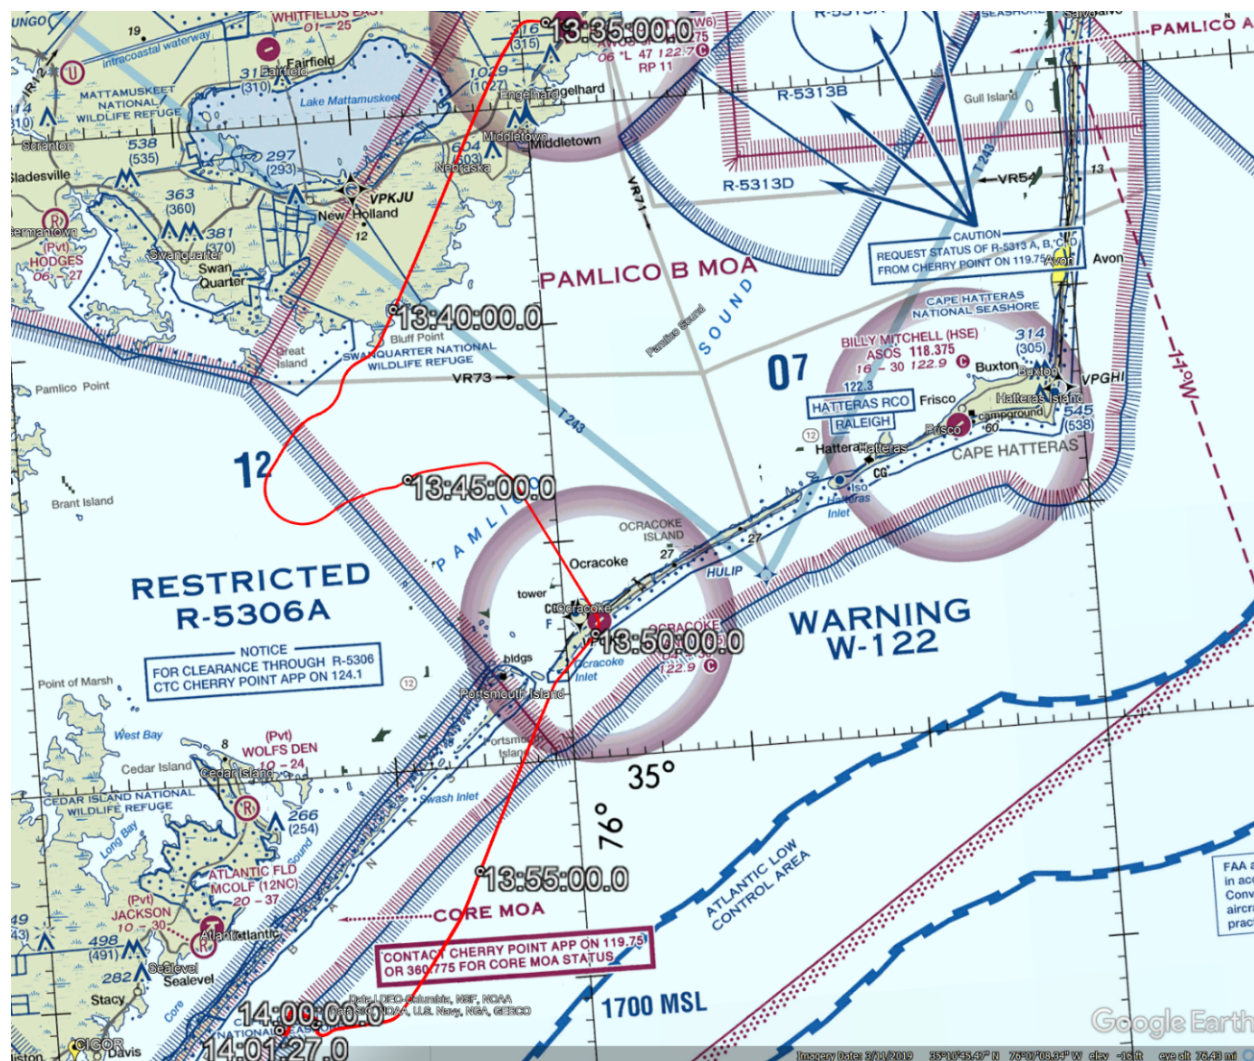
Figure 1. View of the airplane's flight track (red) overlaid onto a visual flight rules sectional chart. The airplane's position at various 5 minute time increments is also labeled.

According to air traffic control data, at 1341, the controller called the pilot and indicated that they were about to enter the restricted airspace. After multiple calls with no response from the accident pilot, the controller instructed the military aircraft that were operating in the restricted airspace to remain above 4,000 ft msl. Although the pilot never responded to the controller, the cockpit voice recorder indicated that the pilot and passenger continued to try and program the

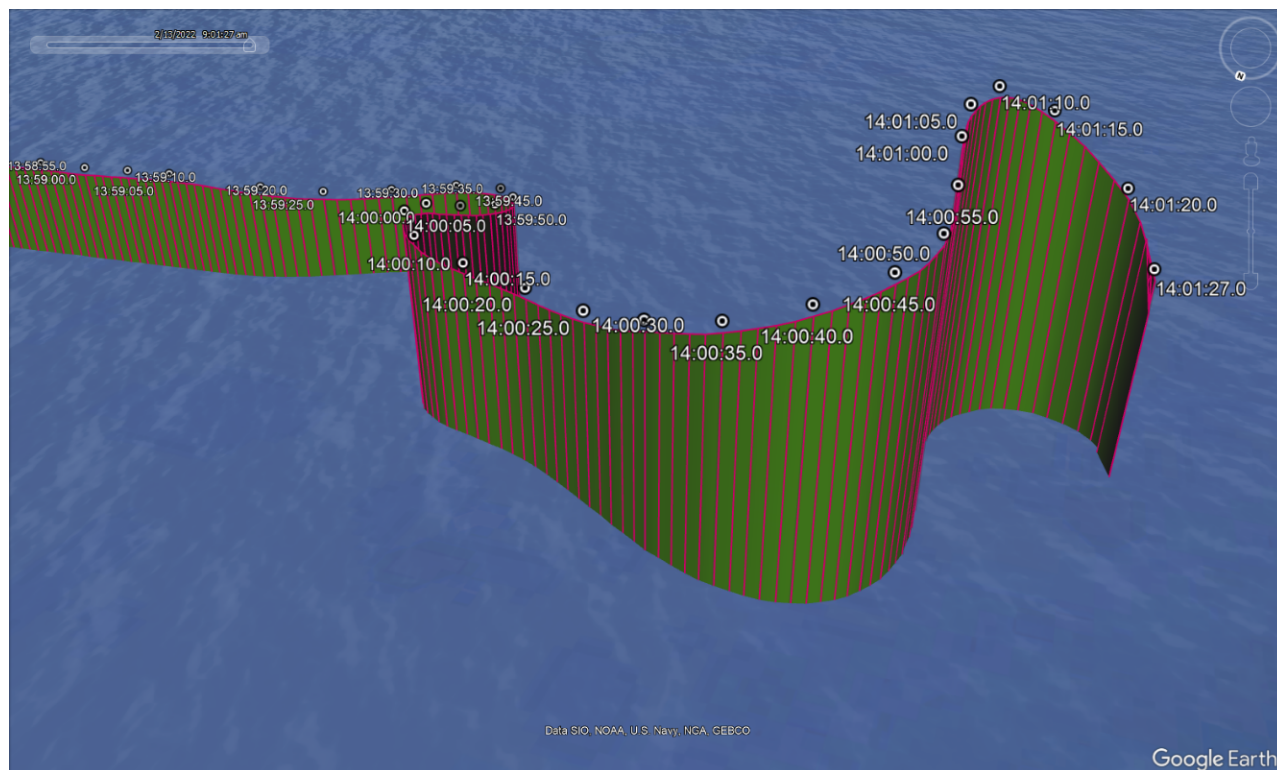
At 1358, the controller contacted the pilot and issued a heading to CIGOR, but then indicated that he had observed that the airplane was "correcting now." At 1358:46, the controller called the pilot and issued the local altimeter setting (the airplane was flying at 1,700 ft msl, but the pilot had been instructed to maintain 1,900 ft msl). The pilot read back the altimeter setting correctly, which was the last transmission from the pilot. At 1358:56, the airplane's barometric altimeter setting changed from 29.98 inHg to 29.96 inHg. At that time, the pitch increased to 10° nose up, while the airspeed had decayed to 109 knots. At 1359:12, the "stall" alert sounded from the CAS, the stick shaker activated, and the autopilot automatically disengaged. The airspeed reached a low of 93 knots and the autopilot remained disconnected for the rest of the recording. At 1359:13, the engine torque increased, which was also correlated with a sound consistent with the engine power increasing. The autopilot disconnect warning sounded continuously at 1359:15 and over the next 2 minutes until the end of the recording. During this time the pilot also continued to make comments about the airplane's navigation system including, "what are we doin'," "it'll navigate," and "activate vectors." At 1359:40, the passenger stated, "we're sideways." Following the stick shaker activation, at 1359:50, the engine power was increased to nearly full power, the stall alert sounded 8 times, the airspeed decayed to 83 knots and the pitch increased to 31.7° when the stick shaker and pusher activated again. At 1401:21, the sink rate alert sounded, and the terrain avoidance warning system announced "pull up" and "speed" before the recording ended at 1401:29. In the final moments of flight, the airplane rolled to a bank of more than 90° to the right and pitched more than 50° nose down. Figure 2 depicts the airplane's horizontal and vertical flight track during the final 2 ½ minutes of the flight.

Figure 2. View of altitude variation during the final 2 ½ minutes of the flight.

At 1401, the controller attempted to contact the pilot to inquire about the airplane's altitude (the airplane was at 4,700 ft msl and climbing quickly). There was no response.
