Aviation Investigation Final Report

Location:	Little Rock, Arkansas	Accident Number:	CEN23FA113
Date & Time:	February 22, 2023, 11:56 Local	Registration:	N55PC
Aircraft:	Beech B200	Aircraft Damage:	Destroyed
Defining Event:	Loss of control in flight	Injuries:	5 Fatal
Flight Conducted Under:	Part 91: General aviation - Business

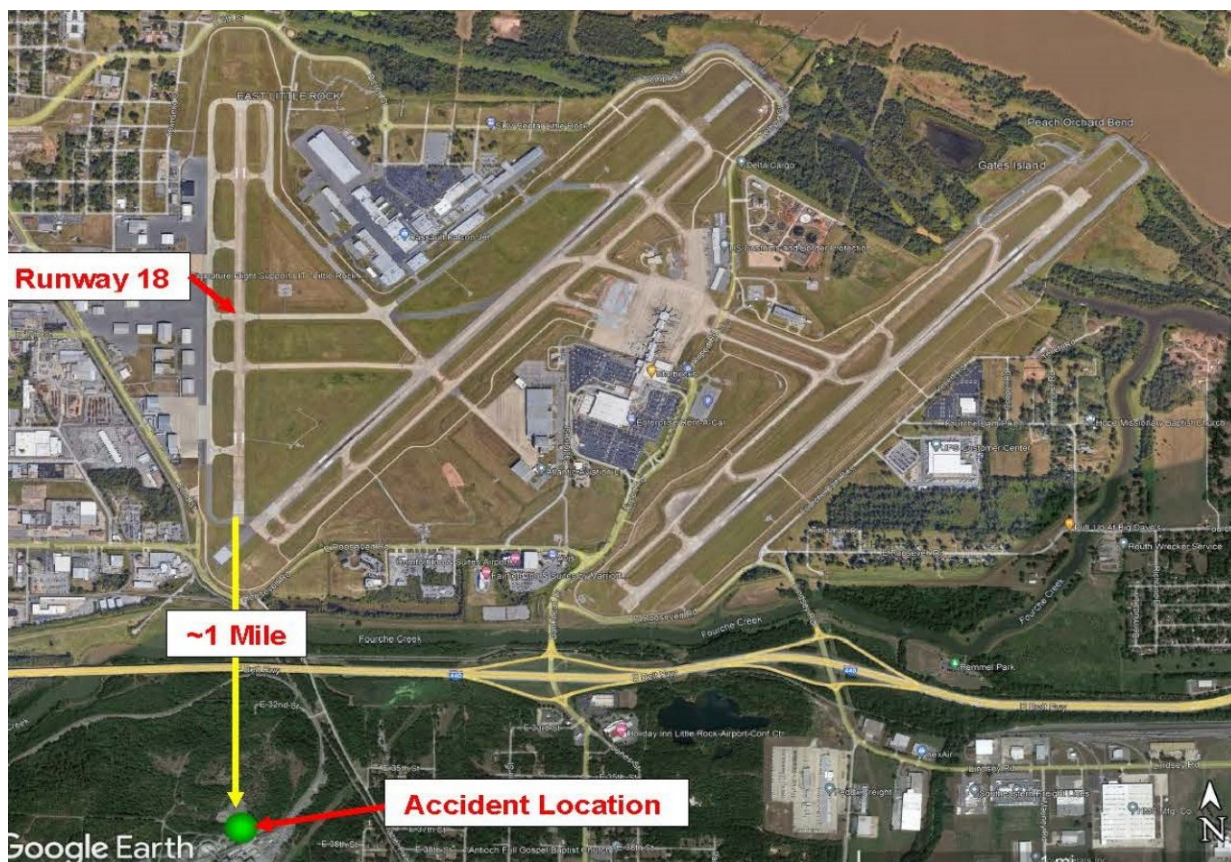
The wreckage of the airplane was found amidst heavily wooded terrain adjacent to a factory about 1 mile south of the departure end of runway 18. (See Figure 1.)

Figure 1. Accident location (green dot) in reference to runway 18 at LIT.

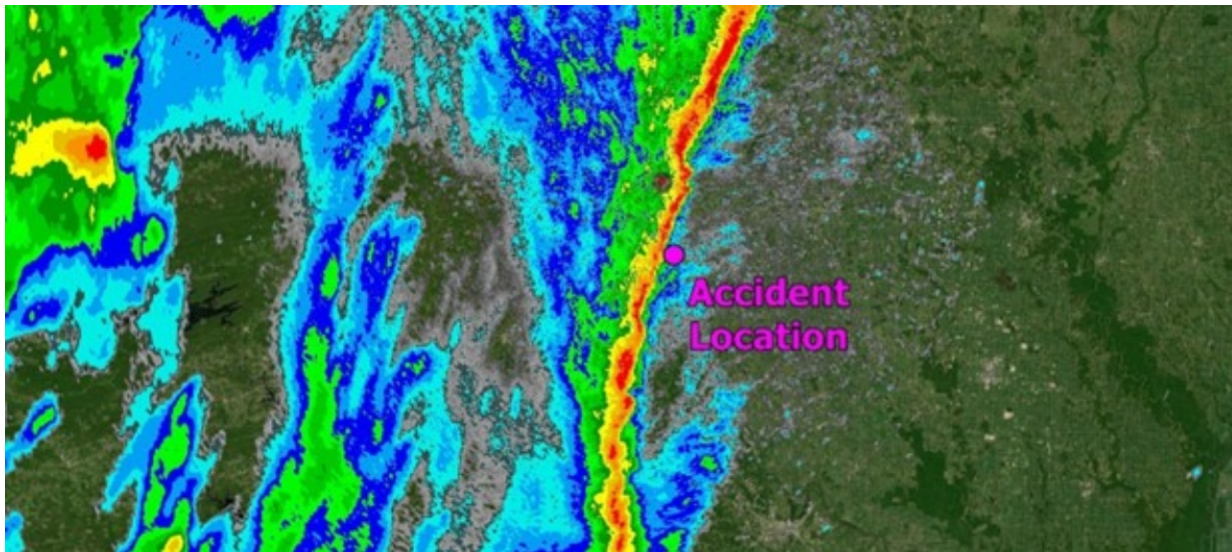
Weather radar imagery identified a line of extreme-intensity precipitation approaching LIT from the west during the period before the accident. (See Figure 2.) Velocity imagery depicted the accident location along a line of radial wind shift about the accident time.

Figure 2. Weather Radar Image. The accident site is depicted by a pink dot.

According to the National Weather Service, based on information gathered by radar, a wind shift occurred about 1 nautical mile to 1.10 nautical miles ahead of the 25dBz precipitation values in the vicinity of the accident site.

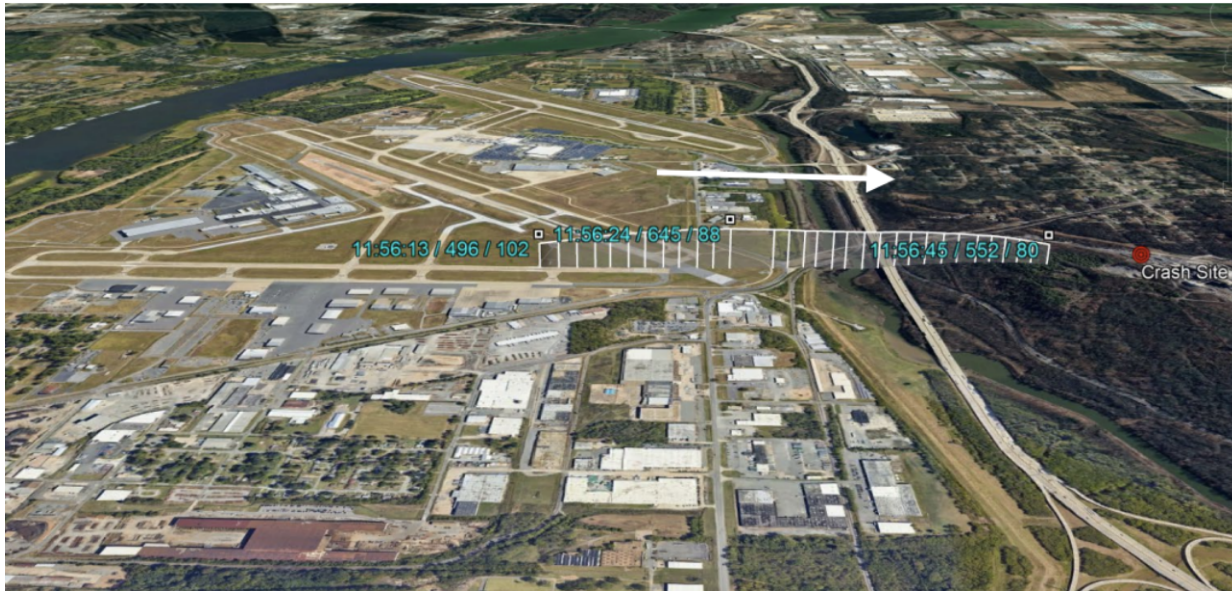
than the total because the engines and propellers are not 100% efficient. During the accident takeoff, the maximum value calculated was only about 900 hp, and after 1156:20, the value was less than 400 hp. A profile view of the airplane's flight path can be seen in Figure 3 below.

Figure 3. Profile view of the accident takeoff with direction of flight denoted by white arrow.

Assuming that the airplane's flaps were retracted during the accident takeoff, the hp calculated during the last 25 seconds of recorded data from the accident flight was about 20% of the hp calculated for the two previous takeoffs. With the flaps fully extended, the hp calculated during the accident takeoff was only about 56% of that calculated from the two previous takeoffs.
