Aviation Investigation Final Report

Location:	Stagecoach, Nevada	Accident Number:	WPR23MA113
Date & Time:	February 24, 2023, 21:14 Local	Registration:	N273SM
Aircraft:	Pilatus PC-12/45	Aircraft Damage:	Substantial
Defining Event:	Loss of control in flight	Injuries:	5 Fatal
Flight Conducted Under:	Part 135: Air taxi & commuter - Non-scheduled - Air Medical (Discretionary)

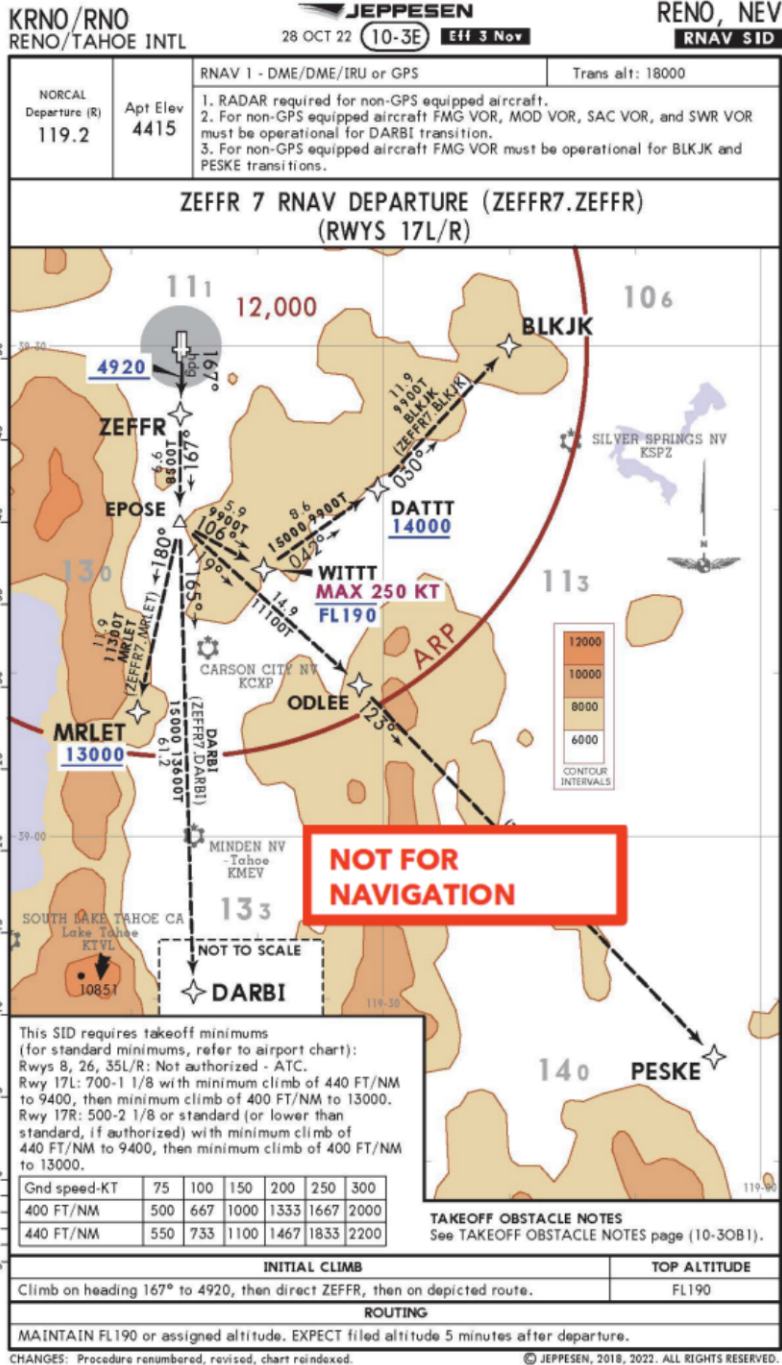
The flight was issued an instrument flight rules clearance to SLC that included the ZEFFR7 standard instrument departure procedure from RNO via the BLKJK transition (see figure 1). BLKJK was a GPS waypoint located about 20 nautical miles (nm) east of RNO. The pilot was cleared for takeoff from runway 17L about 2059, and ADS-B data showed the airplane was airborne about 45 seconds later. About 1 minute later, the pilot was given a frequency change and instructed to contact departure control, which the pilot acknowledged.

Figure 1. ZEFFR7 Standard Instrument Departure Procedure (Source: Jeppesen)

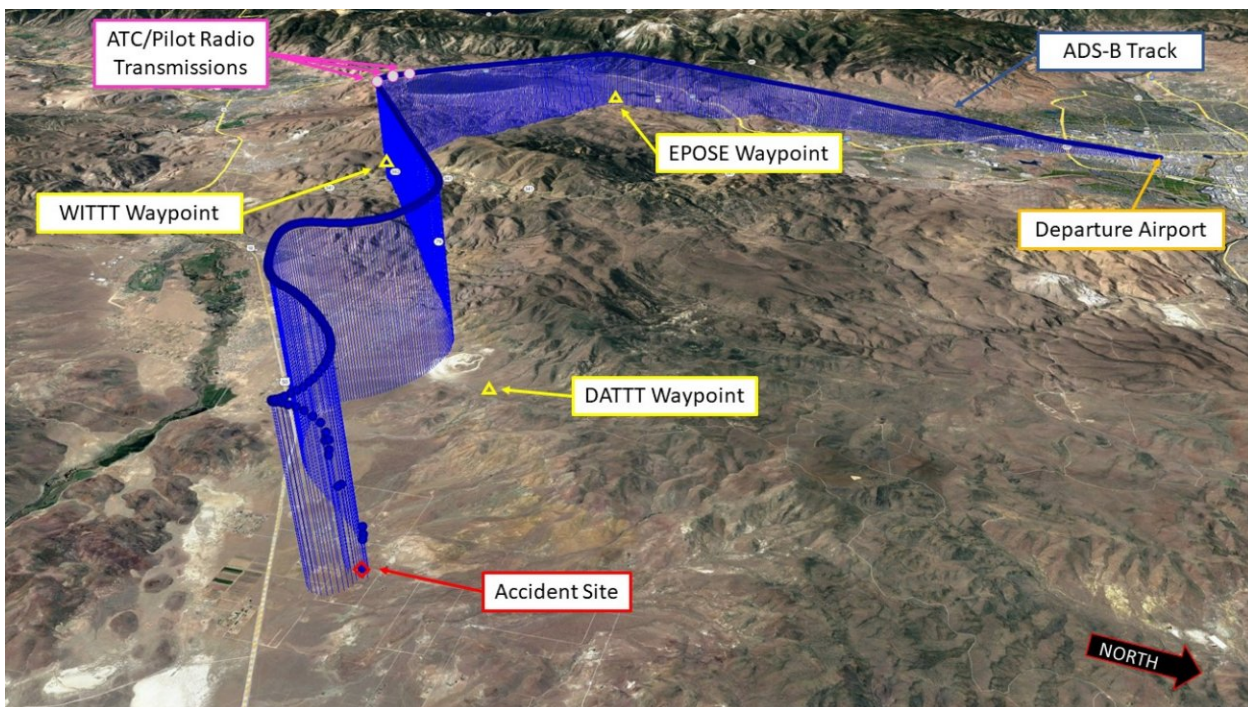
About 2111:15, the airplane began a right turn before reaching the DATTT waypoint, which was the next waypoint along the departure procedure. About this time, the airplane's previously consistent climb rate stopped, with the airplane continuing at an altitude of about 18,300 ft msl for about 20 seconds. The ADS-B data showed that the airplane remained on this heading for about 47 seconds and climbed to about 19,000 ft msl before turning left to a northeasterly heading. The airplane continued on a northeasterly heading and climbed to about 19,400 ft msl before entering a descending right turn about 2113:20. About 2113:30, the airplane's rate of descent increased from about 1,800 ft per minute (fpm) to 13,000 fpm, and the rate of turn increased. The airplane remained in a descending right turn until ADS-B contact was lost about 2114:12 at an altitude of 11,100 ft msl in the vicinity of the accident site. Figure 2 shows the airplane's ADS-B flight track.

Figure 2: ADS-B flight track data with waypoint, accident site, and radio communication reference points annotated.

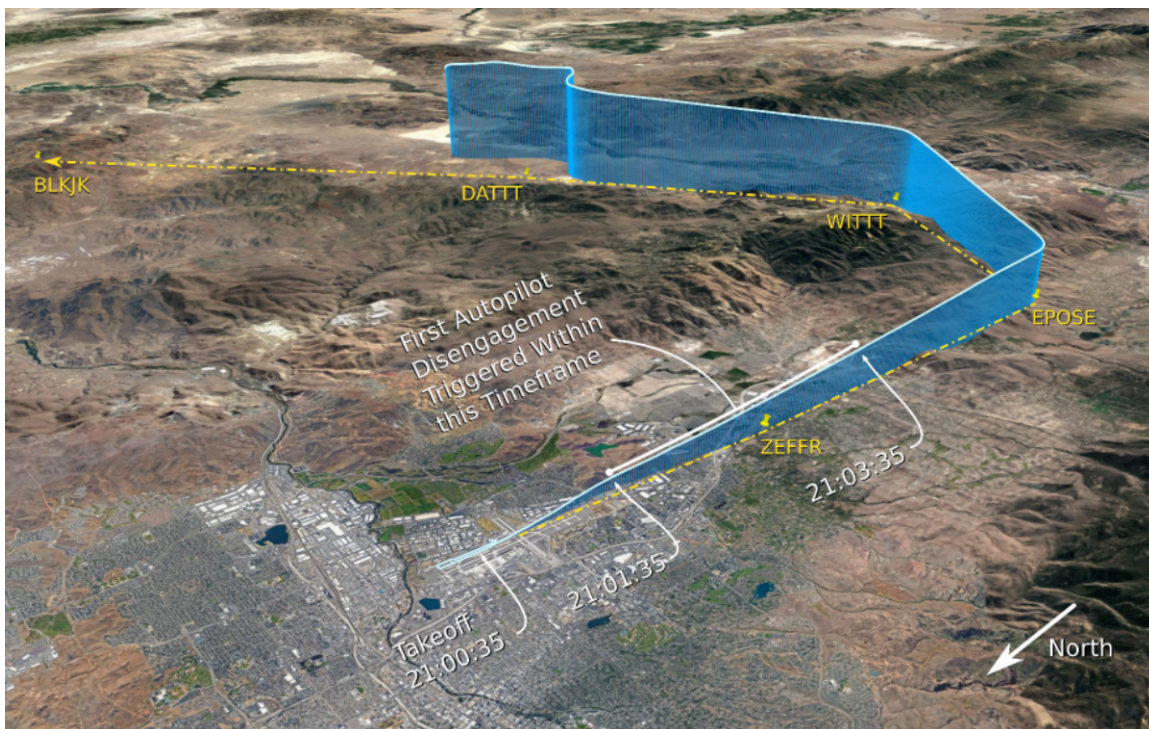
The CAWS computer recorded an autopilot disengagement between 1 and 3 minutes after takeoff (between 2101:35 and 2103:35), as shown in figure 3. The CAWS data showed that the autopilot was reengaged shortly thereafter.

Figure 3: CAWS data map overlay showing the takeoff event and first autopilot disconnect.

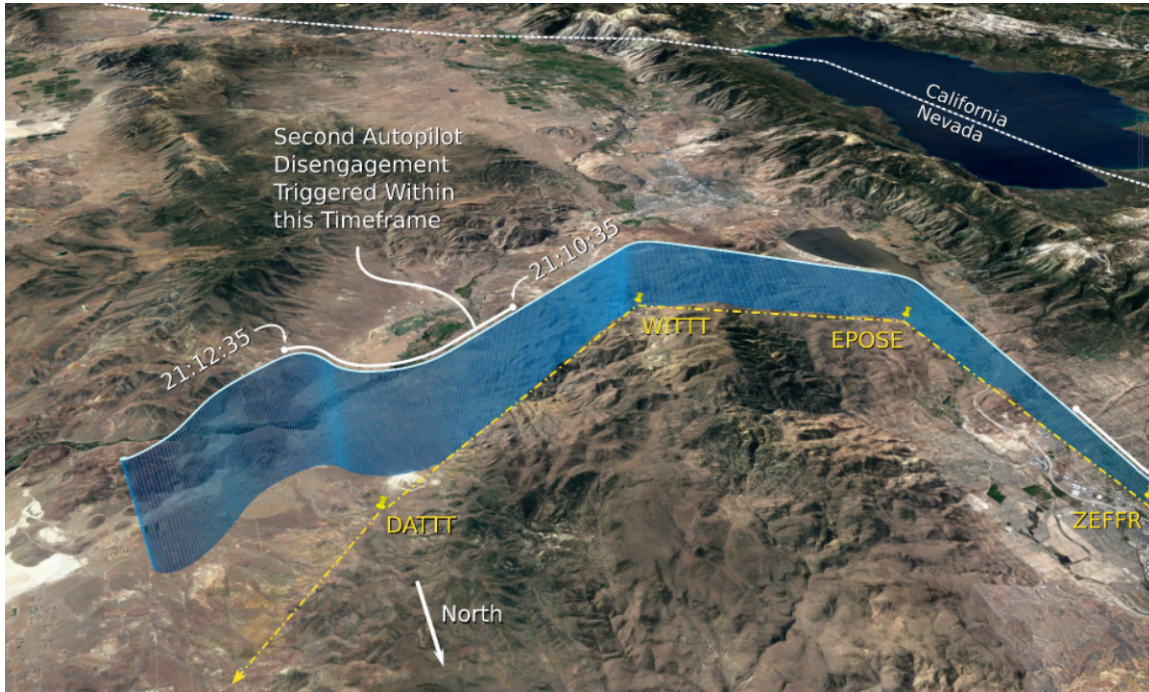
A second autopilot disengagement occurred in minute 16 of the data, or a correlated GPS time between 2110:35 and 2112:35, as shown in figure 4.

Figure 4: CAWS data map overlay showing the second autopilot disconnect.

The CAWS log did not record any annunciations between the last autopilot trim operation and the second autopilot disconnect. This gap was approximately five minutes. After the second autopilot disconnect, the pusher ice mode, pusher and (de-ice) boots green annunciators cleared.

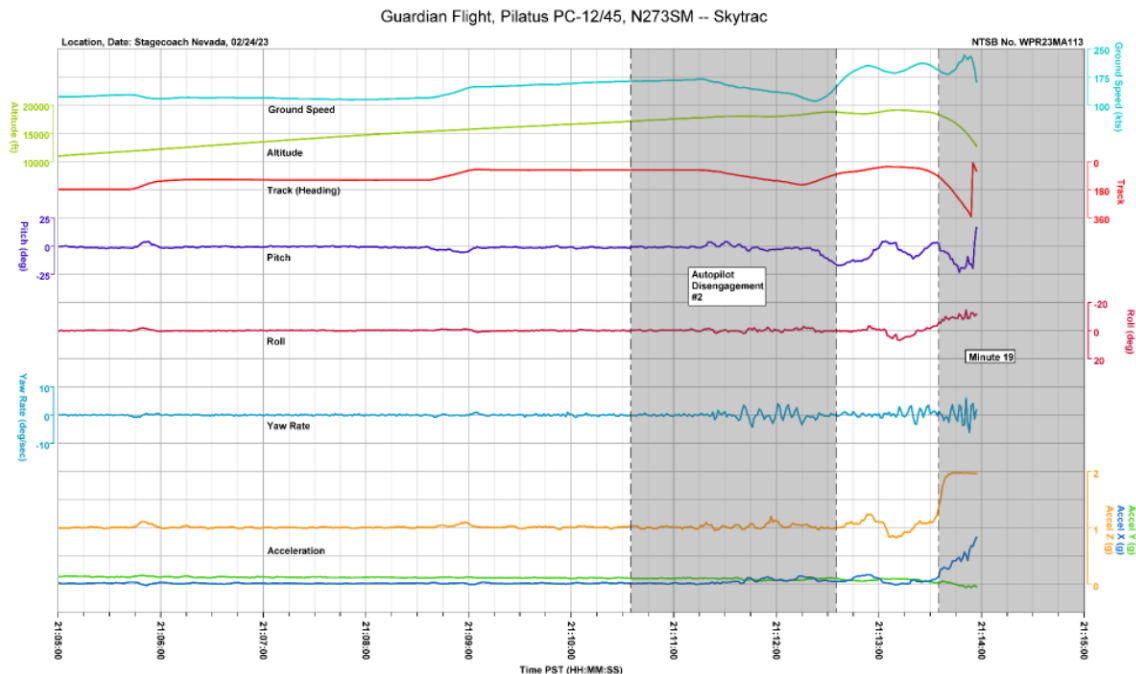
Data from the Skytrac transmitter (as shown below in figure 5), showed that recorded acceleration values asymptotically approached 2g, but never exceeded that value. Skytrac was asked if this was unusual and responded that "The maximum value it will display is the 2G." Pitch, roll, yaw rate, and acceleration data from the Skytrac transmitter was considered as trend data.

Figure 5: Plot of the accident sequence recorded by the Skytrac ISAT-200A. The estimated time frame of the second autopilot disengagement and minute 19 are shown in gray.
